TECHNICAL NOTE 3847

FATIGUE-CRACK-PROPAGATION AND RESIDUAL-STATIC-STRENGTH  
RESULTS ON FULL-SCALE TRANSPORT-AIRPLANE WINGS

By Richard E. Whaley, M. J. McGuigan, Jr.,  
and D. F. Bryan

Langley Aeronautical Laboratory  
Langley Field, Va.

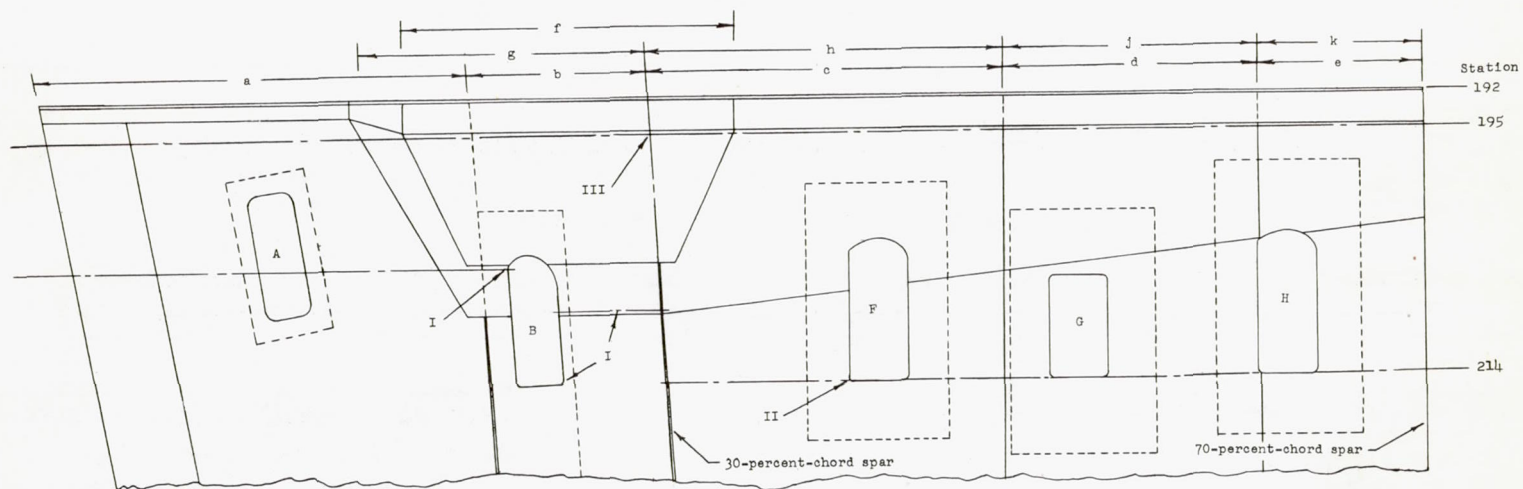
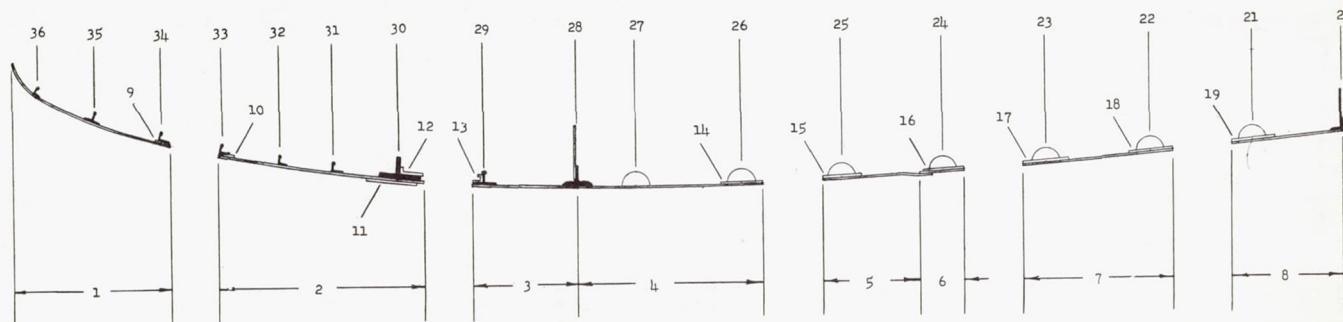
Figure 2.- Details of wing structure and location of failures.

General description of cracks.- All the fatigue cracks that grew until their respective propagation curves indicated that the wing would fail if the test were continued are listed in table II. The cracks occurred at three different locations which are indicated in figure 2 and can be described generally as follows:

Of the 17 cracks reported here, 12 originated in area I, 3 in area II, 1 in area III, and 1 in a machined notch. Nine of the 12 cracks that originated in area I initiated at the edge of the external doubler plate between the 30-percent-chord spar and cutout B. The other three initiated only a few inches away at the outboard rear corner of cutout B. A small crack sometimes originated in the doubler (element 11) in the forward inboard corner of cutout B. This crack never grew until another crack originating in area I progressed to it so both were considered to be in area I. All these cracks progressed through the same elements in approximately the same order.

Elements 1 to 8 apply to skin at span station 214.  
 Elements 9 to 19 apply to doublers at span station 214.  
 Elements 20 to 36 apply to stiffeners at all stations.  
 Elements a to e apply to skin at span station 195.  
 Elements f to k apply to doublers at span station 195.  
 I, II, and III apply to the three failure areas.

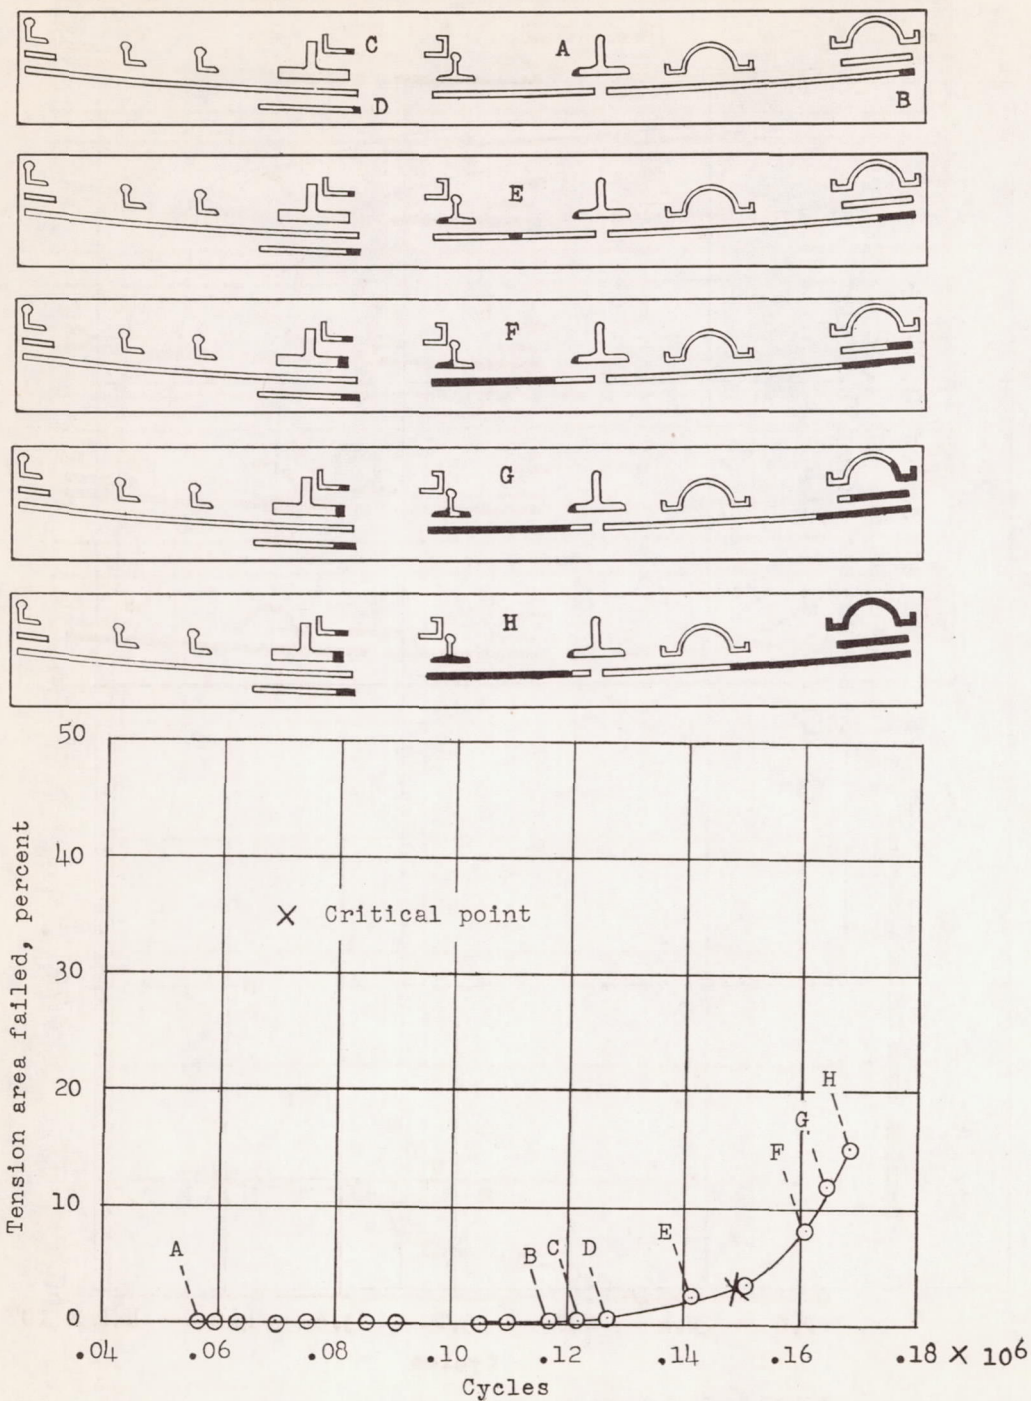
Figure 5.- Concluded.

crack-propagation characteristics. Since all the cracks thus far discussed originated either in the wing skin or doubler plates, an attempt was made to force a crack to initiate in the main (30-percent-chord) spar flange by notching it as previously described. As can be seen from the crack-propagation curve of figure 5(q), the crack originated at the root of the machined notch. The growth of the crack in the spar cap, however, was extremely slow, and before it had grown appreciably cracks originated in three other locations on the wing. Attempts were made to stop drill two of these cracks with 1/8-inch holes in order to obtain the information desired from the spar flange, but the propagation of these cracks was slowed only slightly by the stop drilling. The test was discontinued when about 15 percent of the wing tension area had been failed by the skin cracks whereas the crack in the spar still amounted to only about 7 percent of the spar-flange area. The fact that the propagation curve exhibits a gradual increase in slope in the region of the critical point could be due to the stop-drilling operations and the complicated effects of several cracks growing concurrently. The 30-percent-chord spar appears to be one of the more highly stressed elements in the structure. Since the initial cracking did start at the end of the machined notch, it was expected that the spar flange would fail completely at an early stage. This, however, was not the case. The final failure of the wing, however, occurred much sooner than any other failure at the same load level. This could have been expected if the crack in the spar flanges had progressed through the flange early in the test. The small size of the crack at the end of the test, however, should not have affected the final lifetime.

(q) Crack 1; notched spar;  $\Delta n = 0.625$ .

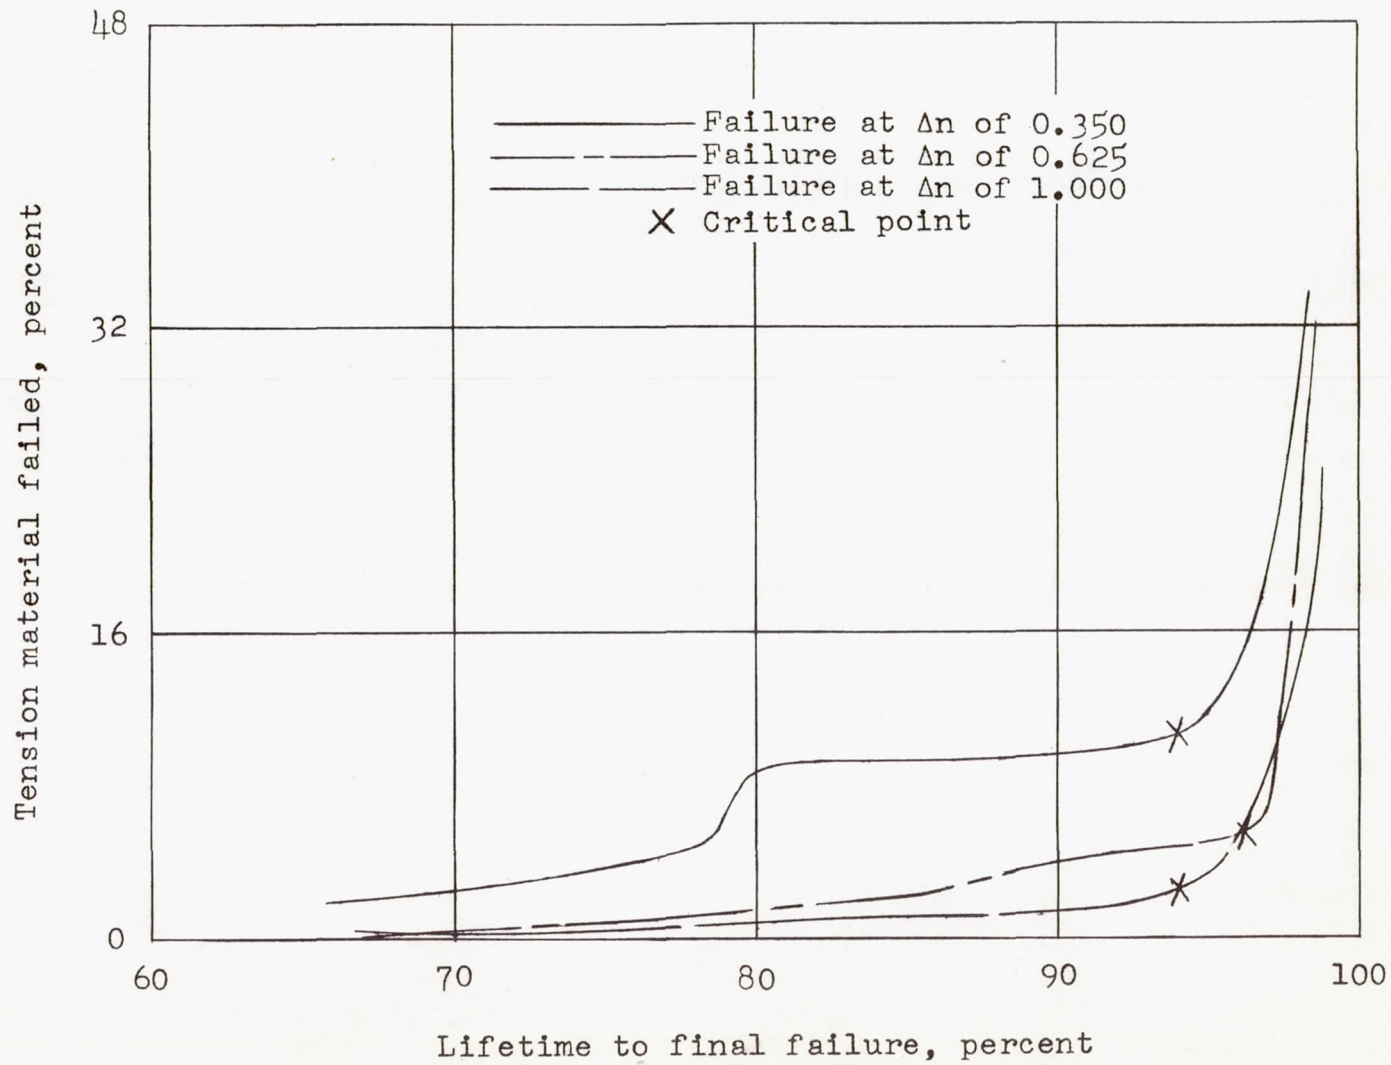
Figure 6.- Typical fatigue-crack propagation.

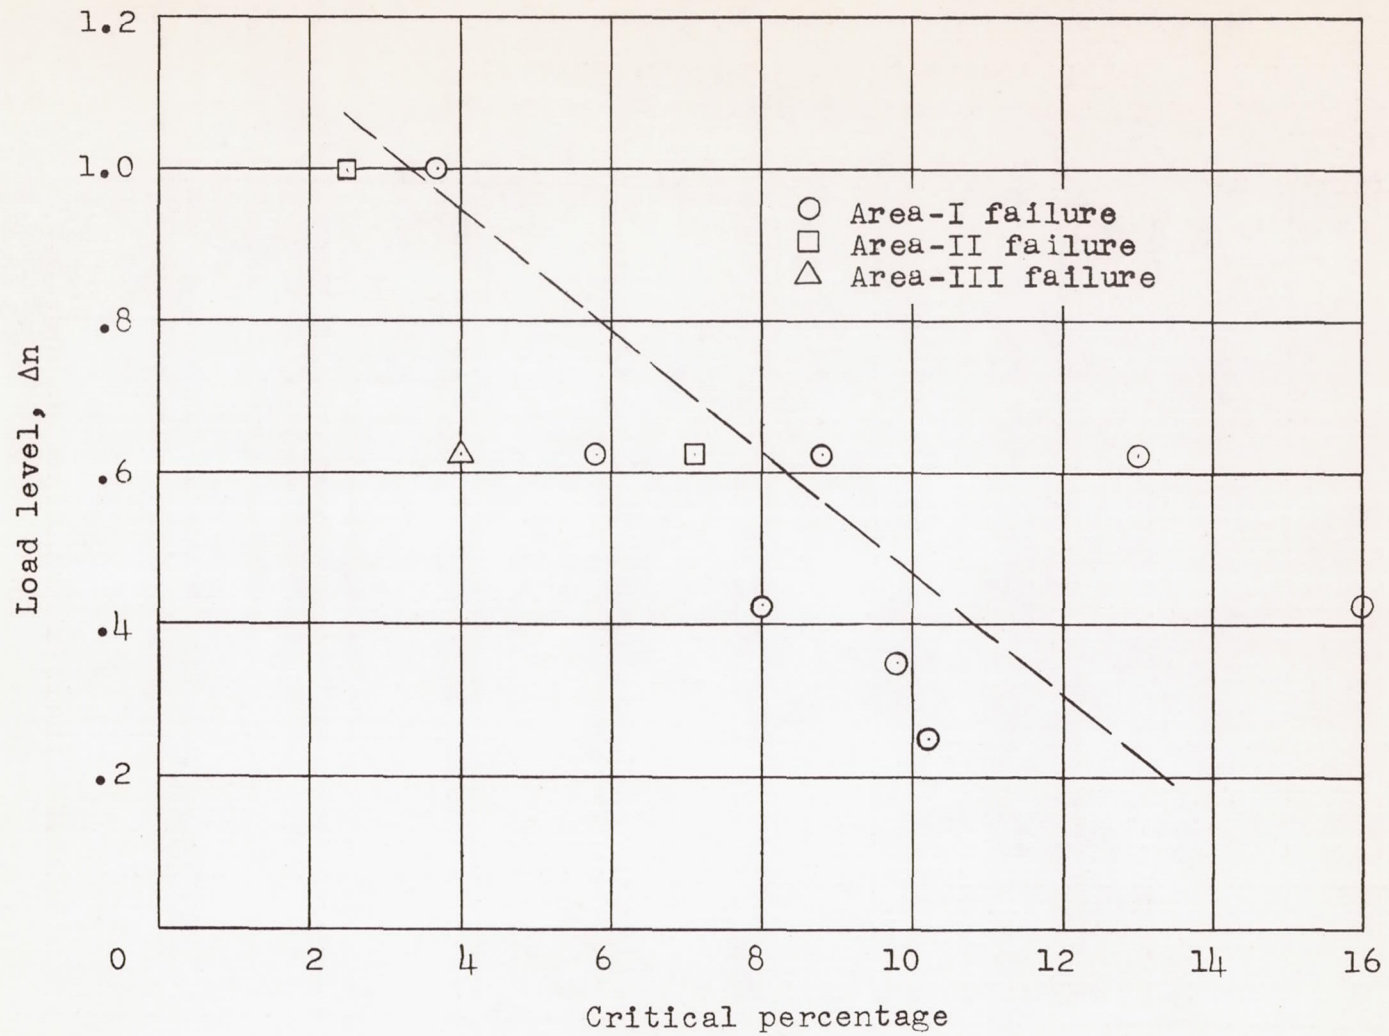
Figure 7.- Tension material failed at critical point.

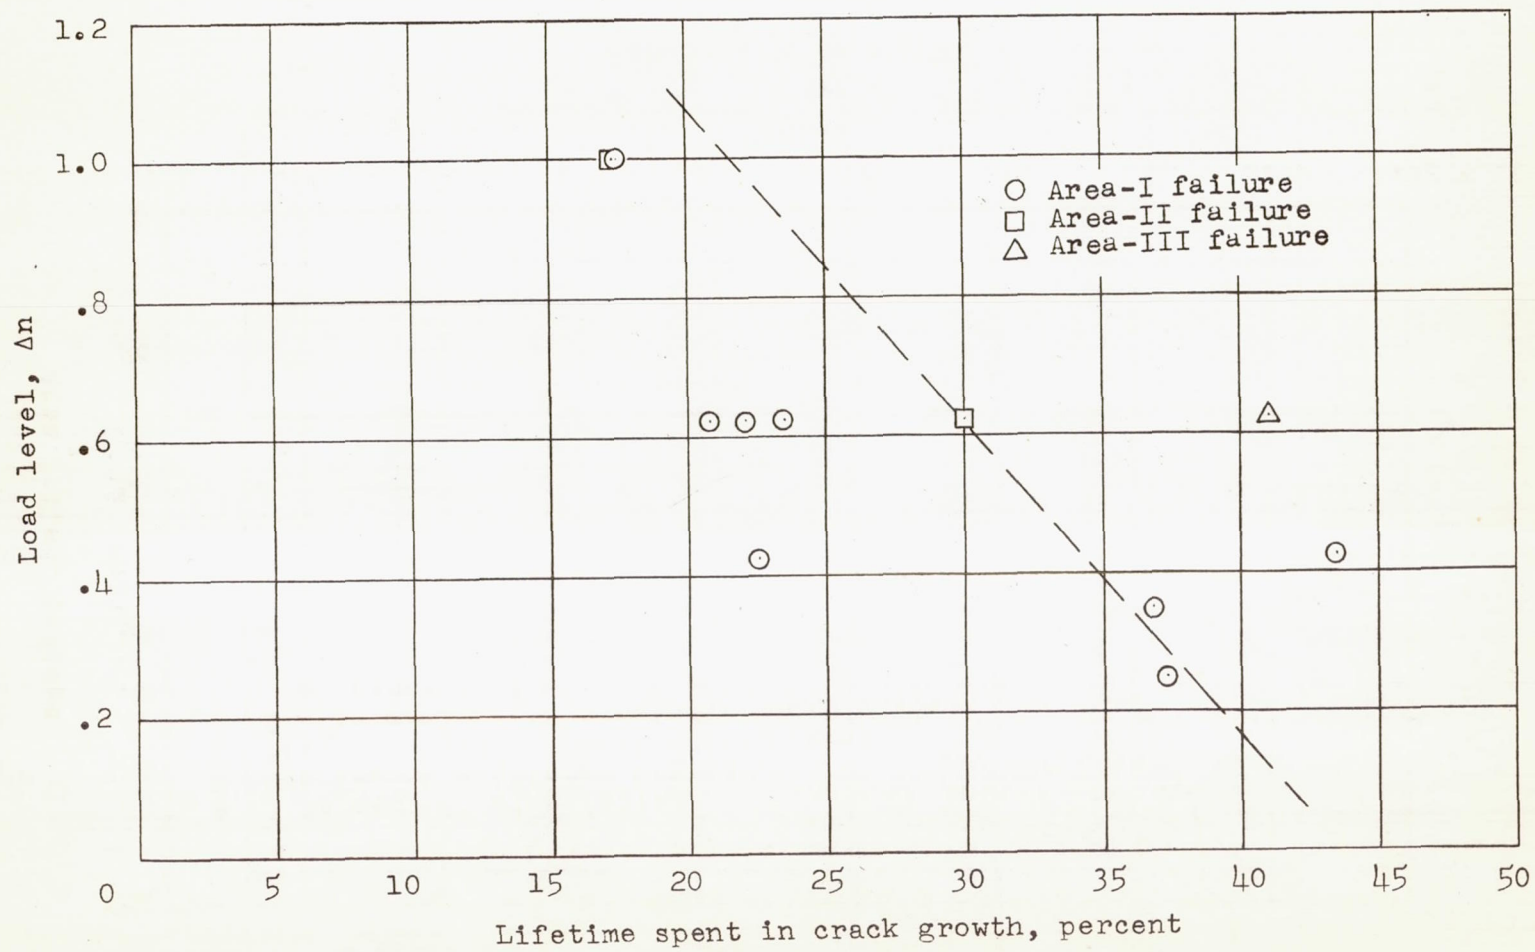
Figure 8.- Lifetime remaining after failure included 1 percent of the tension material.

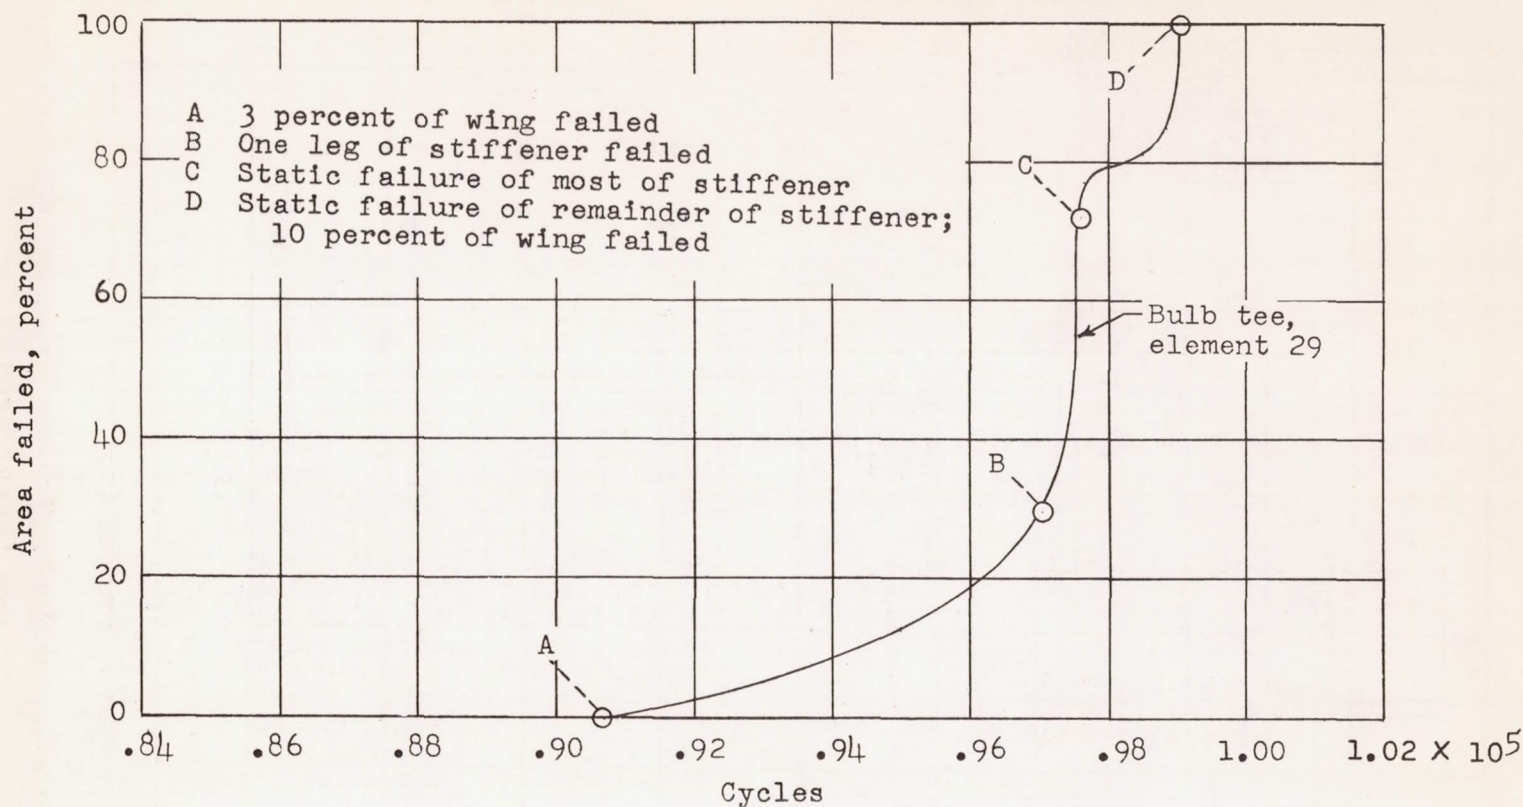
(a) Crack 3;  $\Delta n = 1.00$ .

Figure 9.- Crack propagation through stiffeners and spar caps.

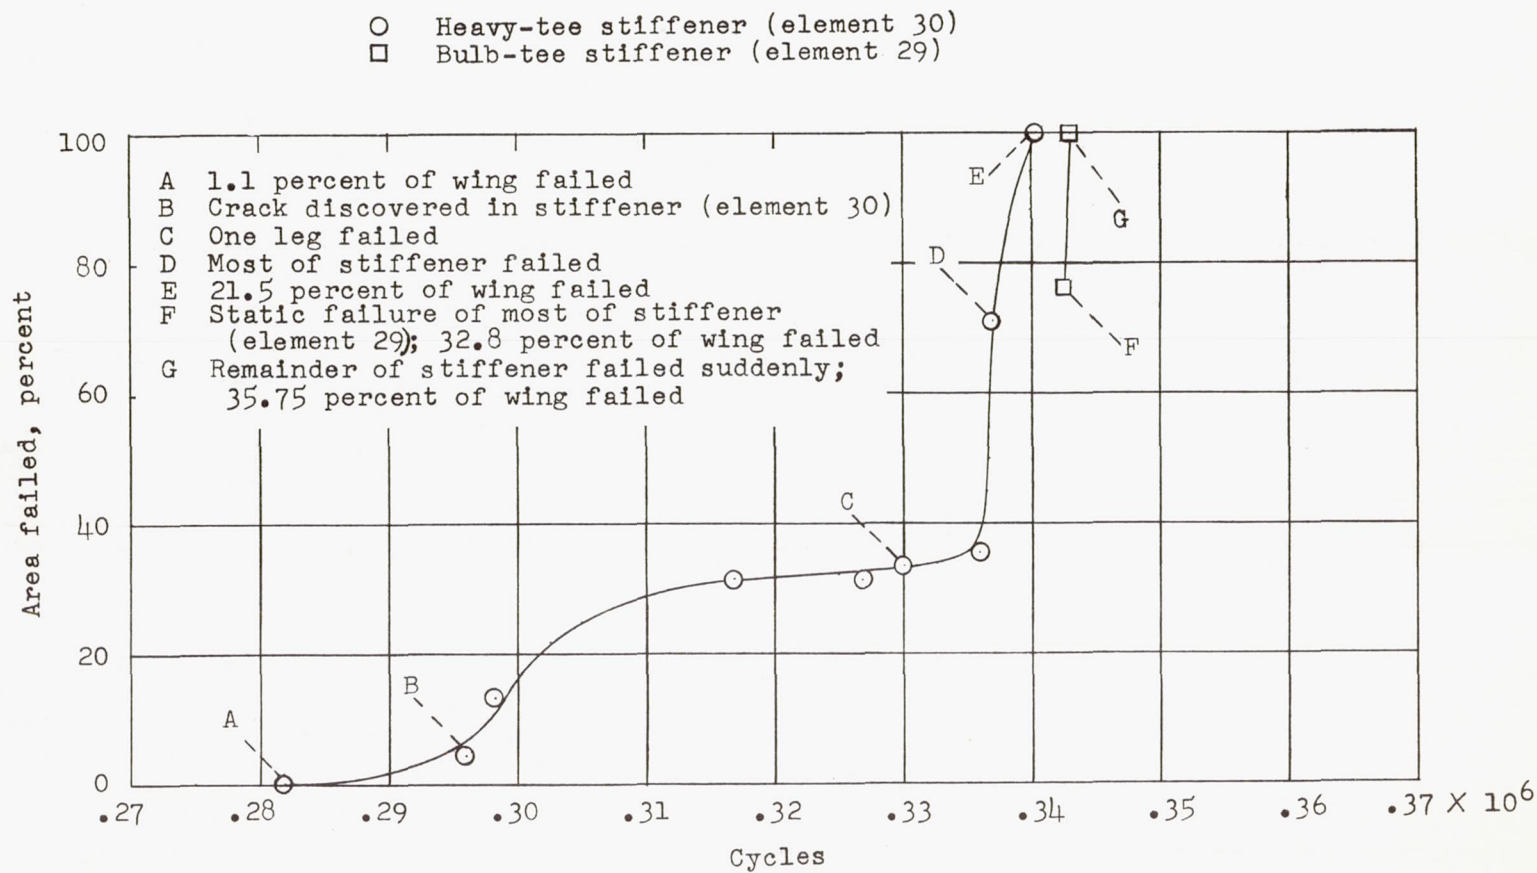
Figure 9.- Continued.

Another propagation curve similar to the propagation curves of the entire wing structure was obtained from another element. This curve is shown in figure 9(b). This element is the heavy tee stiffener (element 30). Although the load level  $\Delta n$  of the test was 0.625, the rate of progress of the crack was slow. One reason for this was that element 30 had a larger area than any other element in the wing and started to fail when the wing had a little more than 1 percent of the entire area failed. The most noticeable difference between this curve and the wing propagation curves was that the critical point occurred at about 35 percent of the area of the element. That point corresponded with the critical point for the whole wing at which time 5.8 percent of the wing tension area was failed. The shape of these stiffener propagation curves depends on the alternating load level and the increase in stress in the stiffener during the test. The failure of the surrounding material causes more load to be added progressively to the stiffener and thus increases the stress. Since the cracks progress through the elements in slightly different orders in each wing, the stiffener propagation curves are subject to some variation.

(b) Crack 15;  $\Delta n = 0.625$ .

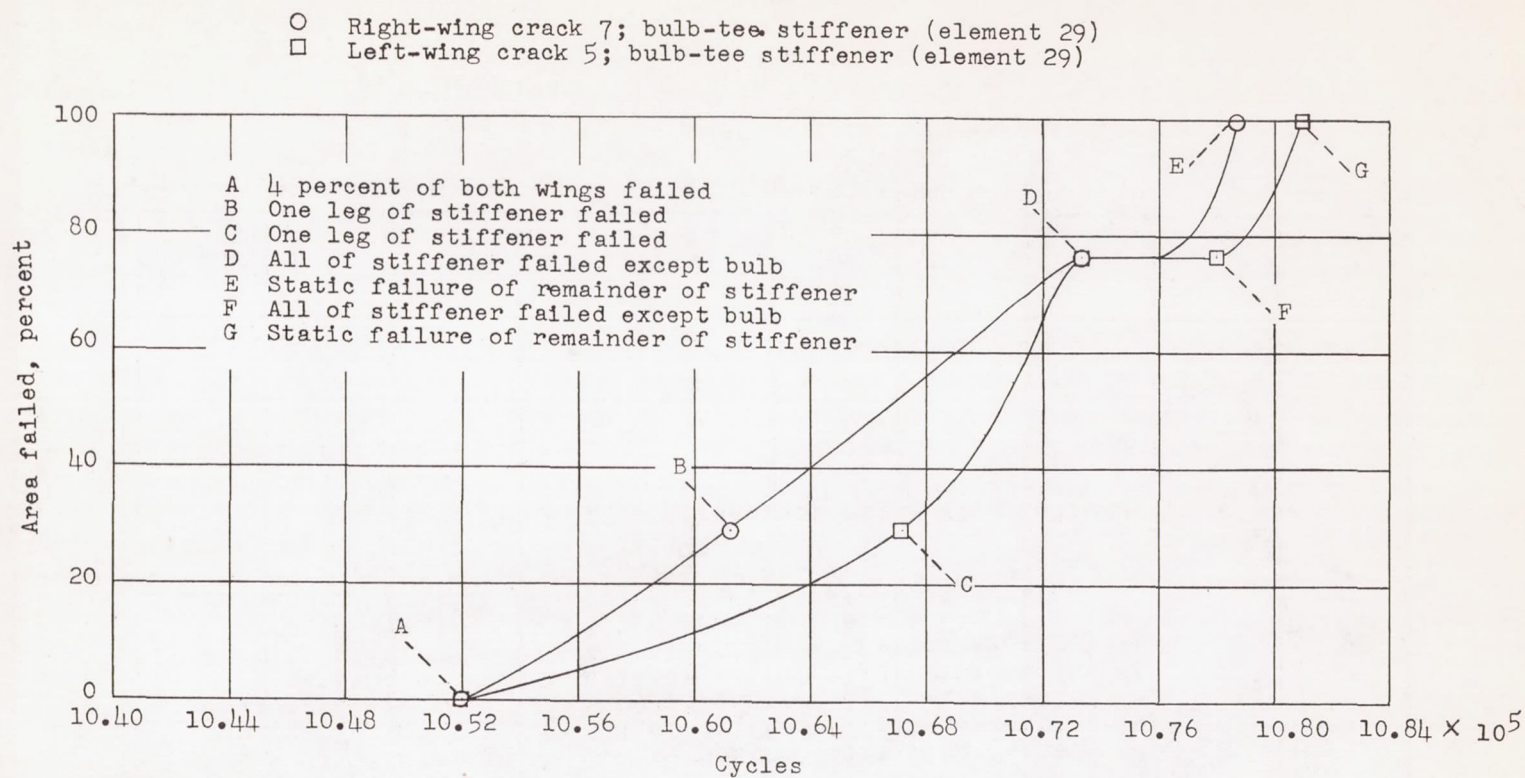
(c) Cracks 5 and 7;  $\Delta n = 0.425$ .

Figure 9.- Continued.

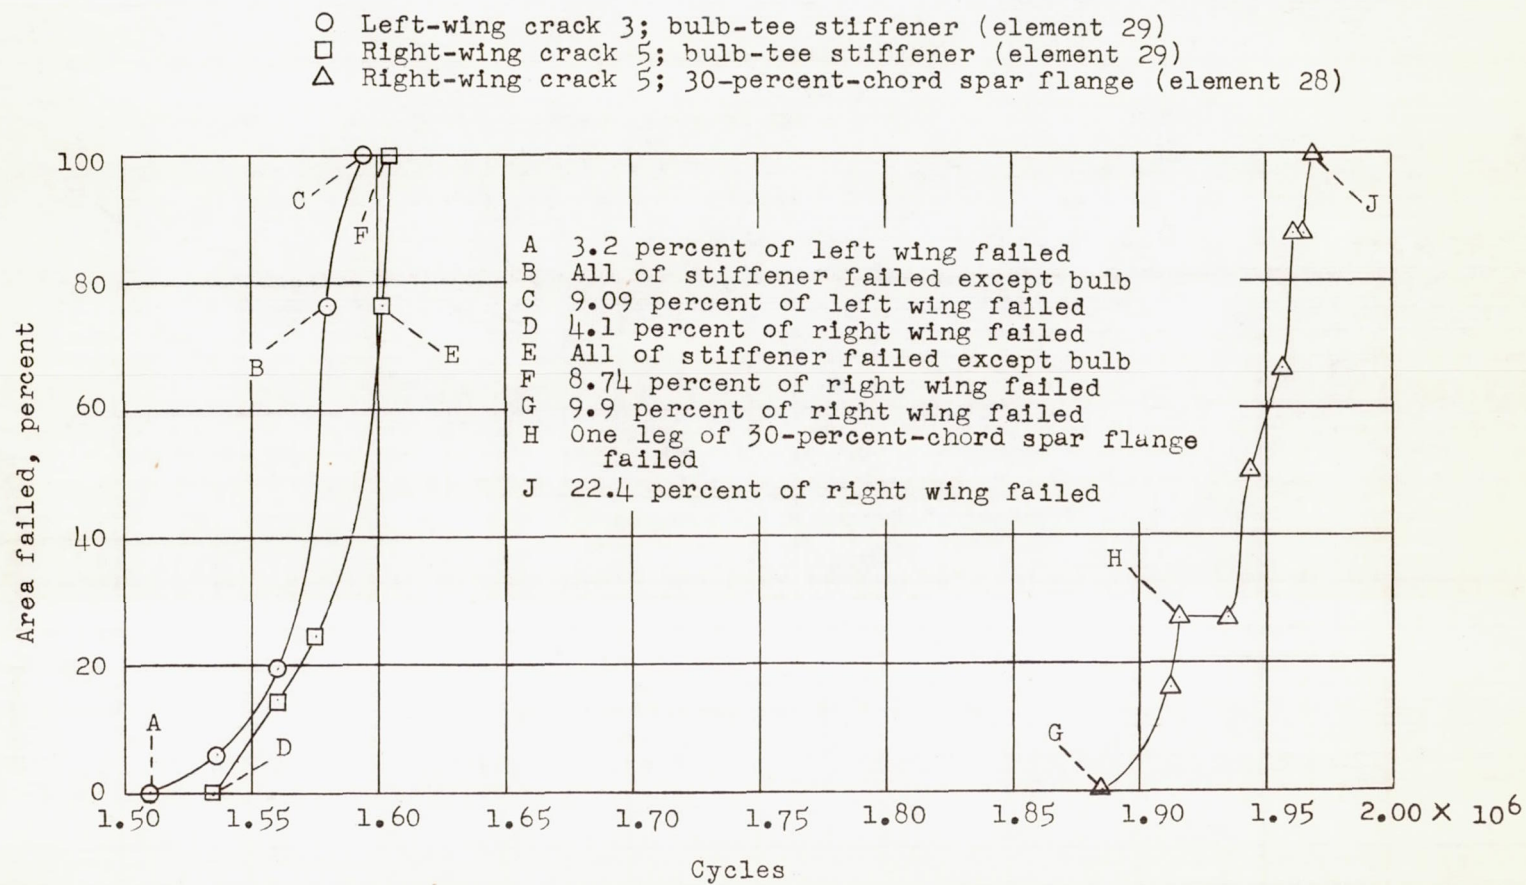
(d) Cracks 3 and 5;  $\Delta n = 0.350$ .

Figure 9.- Continued.

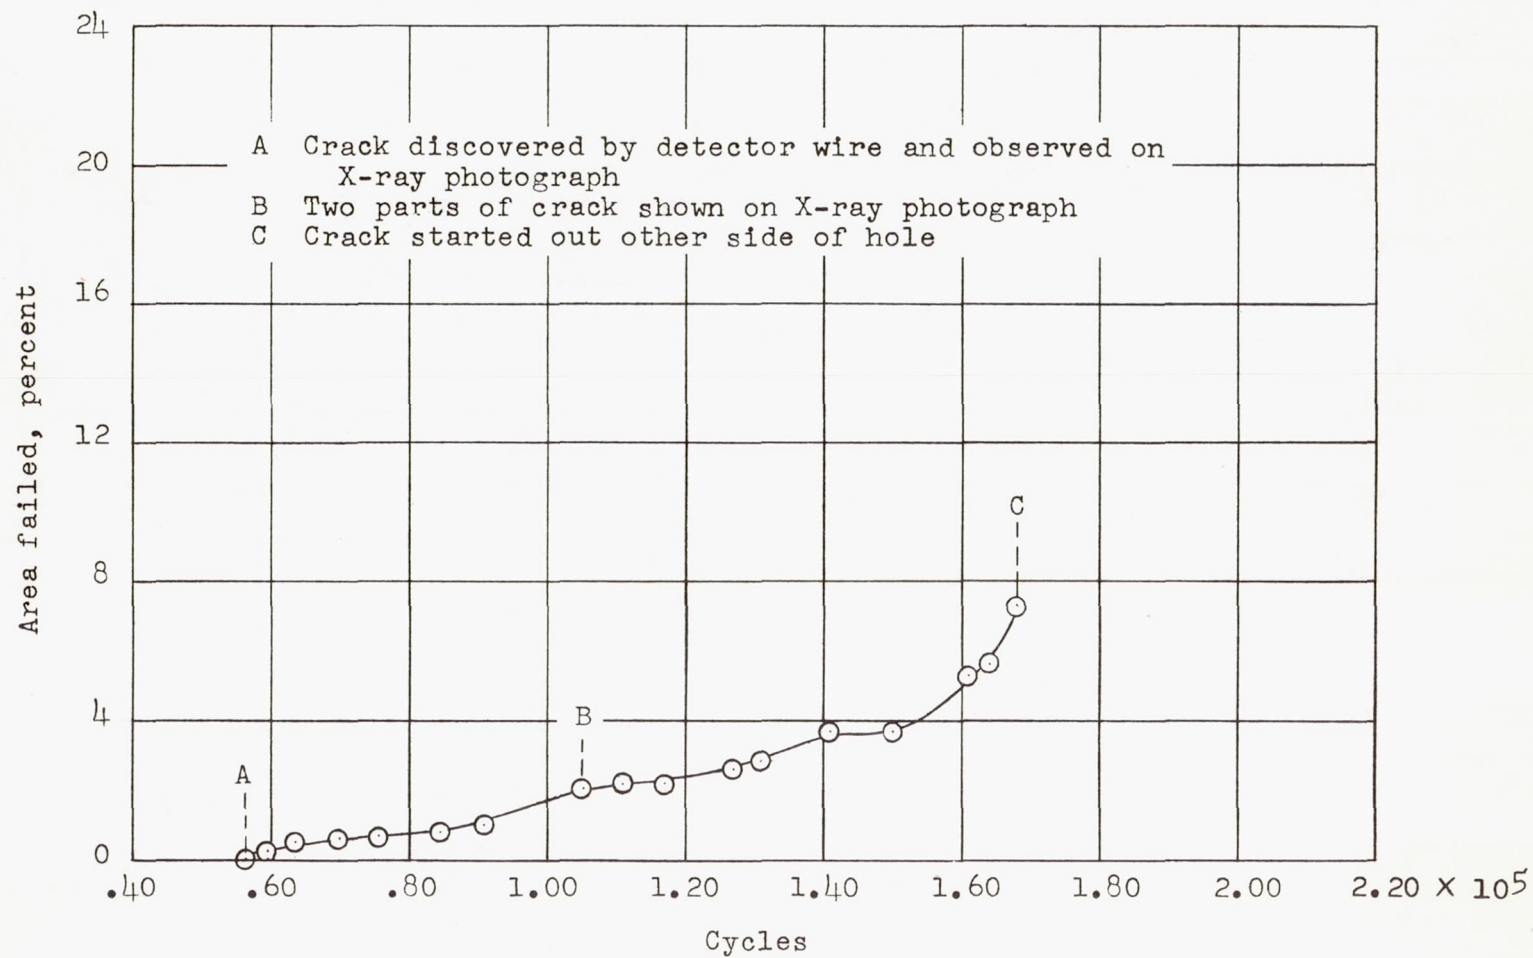
(f) Crack 1; notched spar;  $\Delta n = 0.625$ .

Figure 9.- Concluded.

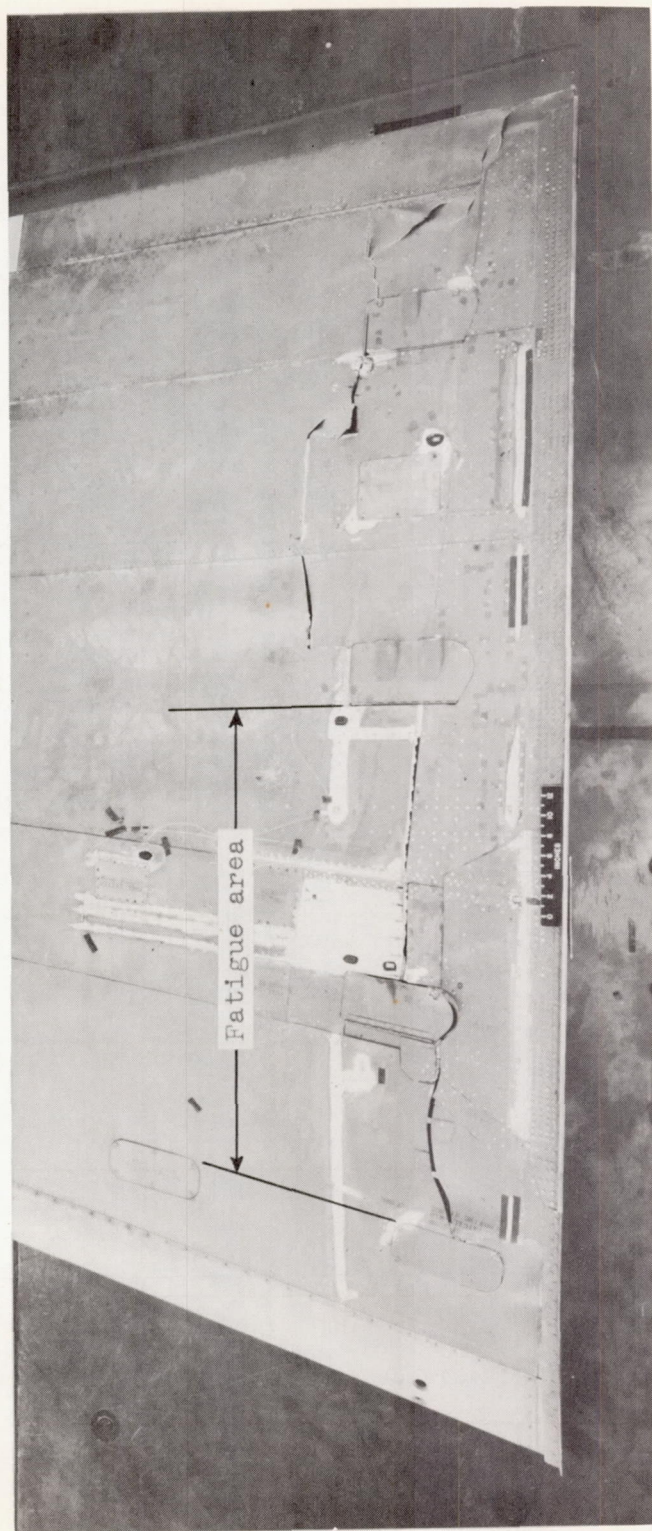
Figure 11.- Illustration of wing after static test.

A photograph of a typical static failure is shown in figure 11. The static failures of the C-46 wings were in general continuations of the fatigue failure already present. The failures usually ran forward from the fatigued area to the foremost inspection cutout and then slanted inboard to the leading-edge attach angle. The leading-edge structure usually failed by shear failure of the rivets attaching the skin to the attach angle. The failure in the rearward direction ran along the line of inspection cutouts at wing station 214 and sometimes shifted outboard to the edge of the internal doubler surrounding each of these cutouts. The 70-percent-chord spar always failed by shearing rivets which attached it to the wing skin and attach angle. The 30-percent-chord spar failed in a similar manner when no fatigue failure was present in this member. There were two cases in which this spar cap fractured when no fatigue failure had been observed to be present in the spar cap. An examination of both of these fractured surfaces after the static tests, however, revealed small regions of fatigue failure which amounted to 1 to 2 percent of the spar-cap area. There were also two cases in which inspection of the heavy tee (element 30) revealed small regions of fatigue failure after the static test.

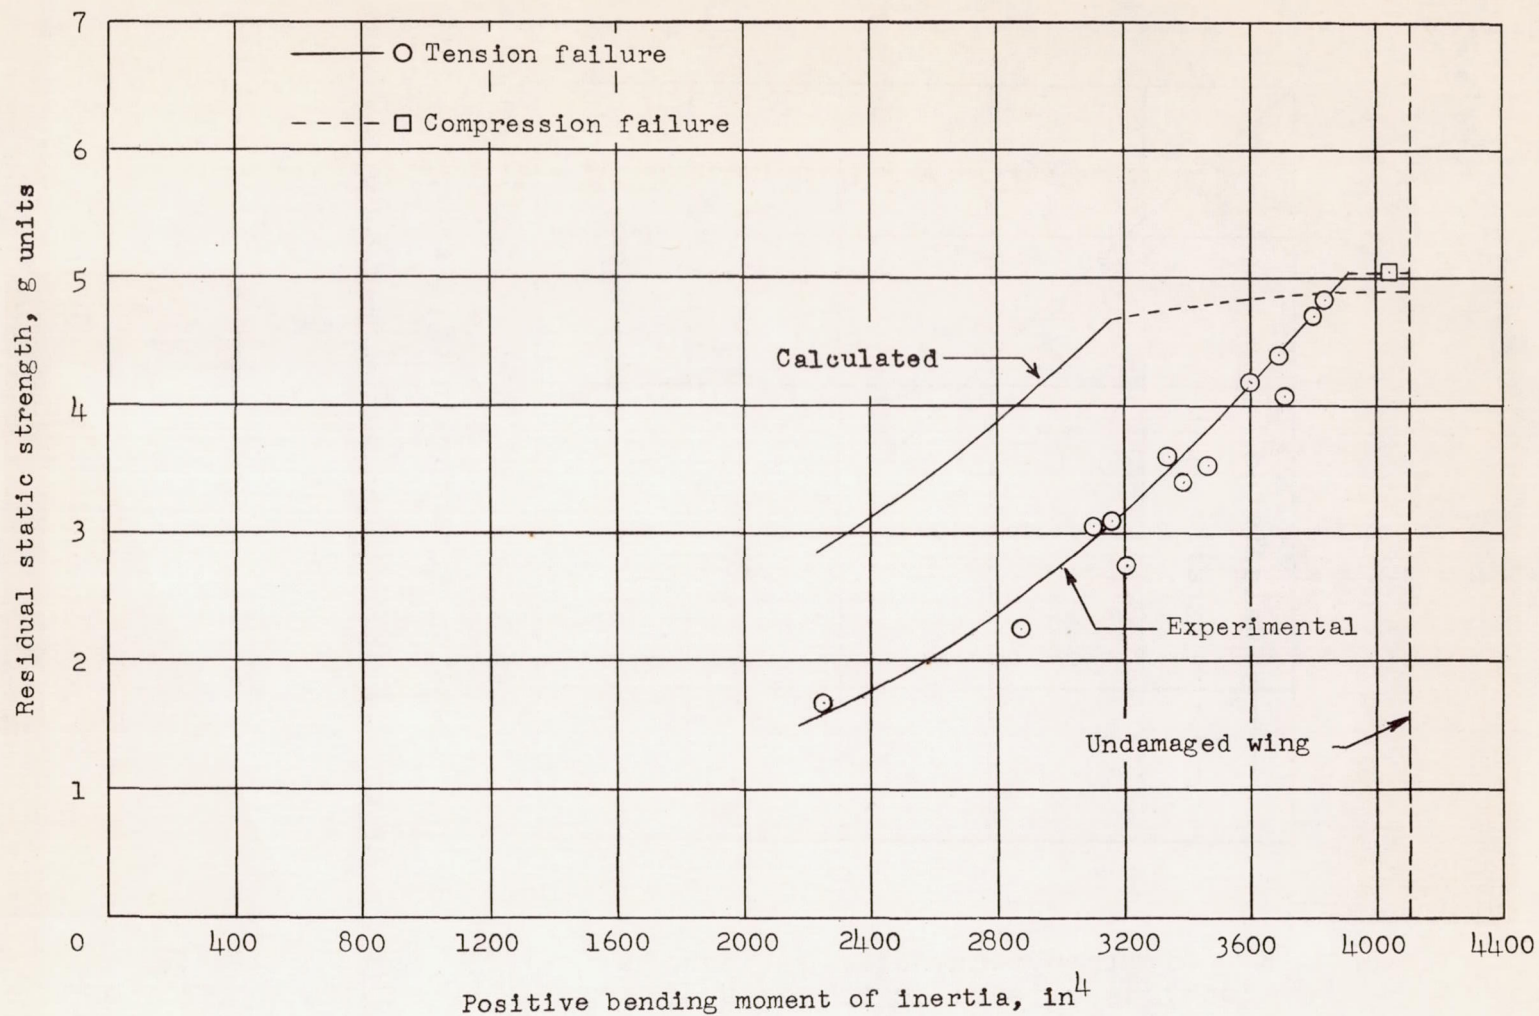
The residual static strength of the C-46 wing based on design-load considerations was very good, as indicated by figure 12, principally because of the large margins of safety in the lower surface of the wing for the positive-loading case. These large margins resulted in relatively small reduction in the bending strength of the whole wing even though the strength of the tension surface itself had been considerably reduced. The large margins of safety for the positive design load were occasioned by the fact that the lower surface of the wing was critical in the negative-loading case in which very small margins were present. In other words, in order to have adequate strength for the negative design load, the lower surface had excess strength in the positive-design-load case.

Figure 12.- Residual static strength of C-46 wing in positive bending.

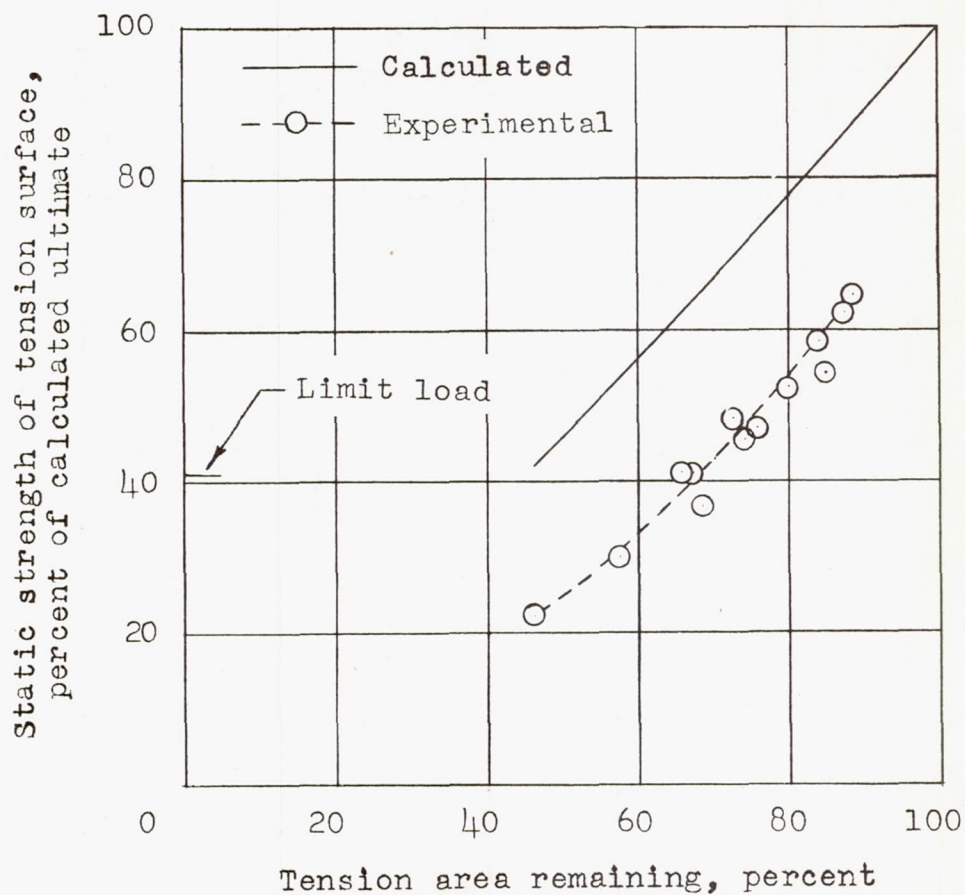
This reduction in strength is shown clearly in figure 13 in which the static strength of the tension surface of the wing is plotted against the percent of cross-sectional tension area remaining in the wing. The solid line in figure 13 shows the relationship between the calculated strength of the tension surface and the tension area remaining after fatigue failure. The calculated strength is based on the reduced section properties of the wing after the fatigue test. Structural analysis of the wing indicated the strength of the tension surface of an undamaged wing to be about 40 percent greater than that of the compression surface for positive bending loads. The calculations indicated that if the compression surface did not buckle the strength of the tension surface would be 7.49g. This value was therefore used as the calculated static strength of an undamaged tension surface, and the actual static strengths obtained from the tests are plotted as a percentage of this figure. No static-strength reduction factor due to holes or cutouts was used in this calculation.

It can be seen in figure 13 that the actual strength is less than the calculated strength by about the same amount throughout the range of the test values. This reduction amounts to about 23 percent of the static strength of an undamaged wing. This reduction in strength can also be expressed as a static-strength reduction factor which is defined here as the ratio between the calculated strength and the actual strength at the same percentage of material remaining. This factor is calculated for each wing and is listed in table III. In figure 14 this static-strength reduction factor is plotted against the percent of tension area remaining in the wing. This figure indicates that as the amount of tension area remaining in the wing decreases the static-strength reduction factor increases. This increase is due to the static strength decreasing while the difference between the calculated strength and the actual strength remains constant. This factor can be used directly along with the calculated strength to find the actual strength.

The residual-static-strength data, figure 13, indicate that the C-46 wing could withstand, without failure, a positive gust which produced a load factor equivalent to the design limit load with as much as 30 percent of the lower cross-sectional area failed in fatigue. Therefore, a considerable length of time should exist in which the crack would be large enough to be easily discovered and during this time the wing could withstand without catastrophic failure any load that the airplane would be likely to encounter.

Figure 13.- Residual static strength of tension surface of C-46 wing.

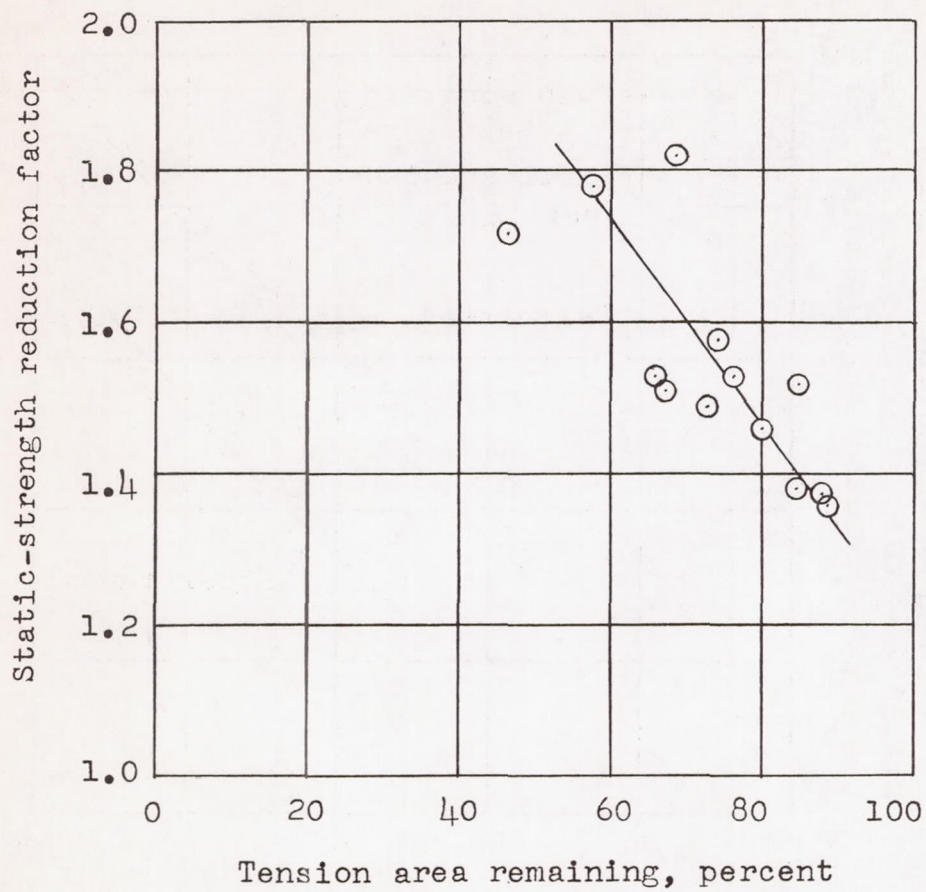
Figure 14.- Static-strength reduction factors for C-46 wing.

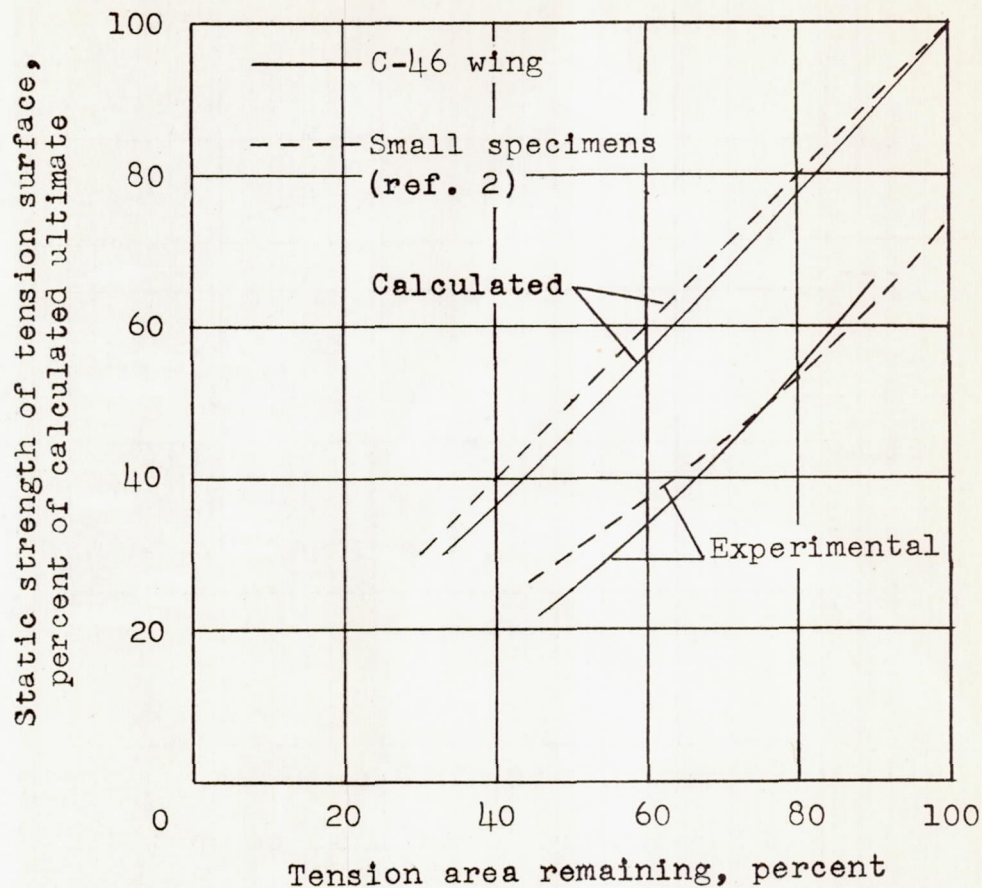
In figure 15 the residual static strength of the wing tension surface is compared with the results of tension tests conducted on  $2\frac{1}{4}$ -inch-wide 2024-T3 aluminum specimens (ref. 2). It can be seen that there is remarkably good agreement between the two. Extrapolation of the results of the full-scale tests to near the region of the undamaged wing indicates that a considerable reduction in static strength of the tension surface would result from a very small fatigue crack.

Figure 15.- Comparison of residual static strengths of C-46 wing and small specimens.
